Manhole Inspection Summary

Manhole # S33A__067MH

Insp Date: **8/19/09 3:42 PM**

Location Address: **ACROSS FROM 617 PARK AVE** Cross Street: **W MONUMENT ST**

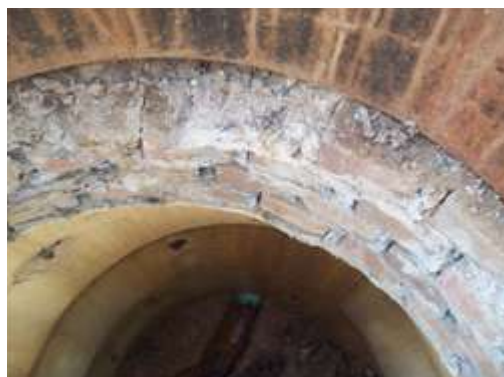
Defect 1

Frame Offset: **3** (in.) Condition: ☒ Sound ☐ Cracked ☐ Leaks

3" OFF SET FRAME

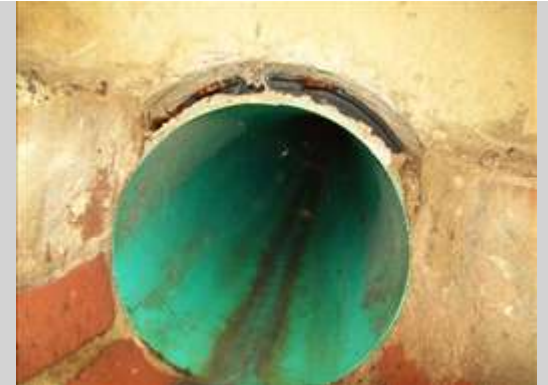
12 O'Clock Outflow

8 in. Circular Gravity Sewer
Pipe Out @ 12 O'Clock

Pipe Height: (in.) Direct
Pipe Material: **PVC** ☐ Pipe Lined
Invert Depth: **9.24** (ft.) Flow Characteristics: **Slow**
Deposits: ☒ None ☐ Mud ☐ Sludge ☐ Debris ☐ Grease
Silt Depth: (in.) Deposits Extent:
Infiltration: **None** Pipe Seal Cond: **Sound**

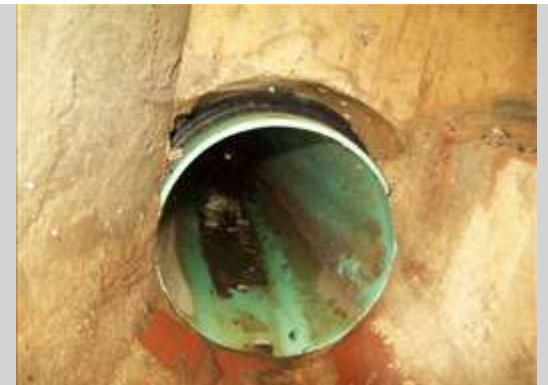
3 O'Clock Inflow

6 in. Circular Gravity Sewer
Pipe In @ 3 O'Clock

Pipe Height: (in.) Direct
Pipe Material: **PVC** ☐ Pipe Lined
Invert Depth: **9.15** (ft.) Flow Characteristics: **Slow**
Deposits: ☒ None ☐ Mud ☐ Sludge ☐ Debris ☐ Grease
Silt Depth: (in.) Deposits Extent:
Infiltration: **None** Pipe Seal Cond: **Sound**

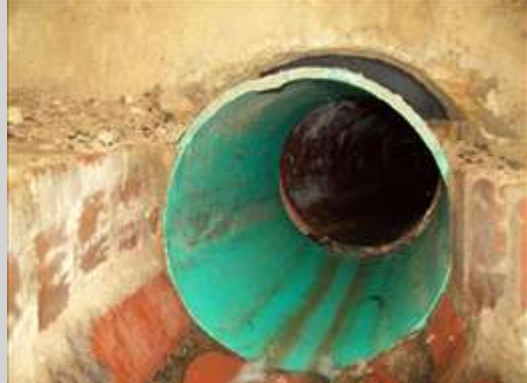
9 O'Clock Inflow

10 in. Circular Gravity Sewer
Pipe In @ 9 O'Clock

Pipe Material: **PVC** ☐ Pipe Lined

Invert Depth: **9.15** (ft.) Flow Characteristics: **Slow**

Infiltration: **None** Pipe Seal Cond: **Sound**
